Thermal Gradient Mechanical Fatigue, Hardness, Adhesive Strength, and Erosion Resistance of Layered $\text{La}_2\text{Zr}_2\text{O}_7$ Thermal Barrier Coatings

Guo, X., Li, L., Park, H.-M., Knapp, J., Jung, Y.-G., & Zhang, J. (2018). Mechanical Properties of Layered $\text{La}_2\text{Zr}_2\text{O}_7$ Thermal Barrier Coatings. *Journal of Thermal Spray Technology*, 27(4), 581–590. <https://doi.org/10.1007/s11666-018-0703-5>

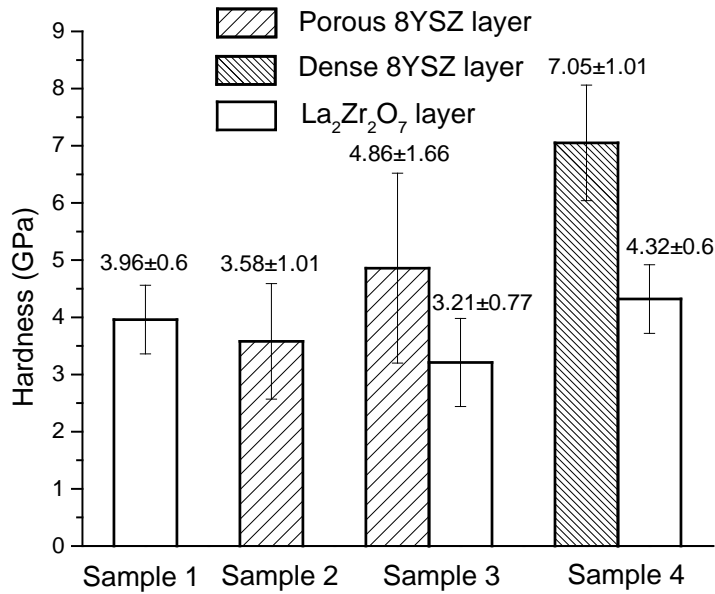
Fig. 3. Vickers hardness in different layers of TBC samples.

The measured average density and porosity of $\text{La}_2\text{Zr}_2\text{O}_7$ were 5.31 g/cm^3 and 12.27 %, respectively; and the porosity of porous 8YSZ samples was in the same level as porous $\text{La}_2\text{Zr}_2\text{O}_7$. The Vickers hardness of porous 8YSZ coatings was similar as $\text{La}_2\text{Zr}_2\text{O}_7$ coatings, as shown in Fig. 3 . However the hardness of dense 8YSZ coating was much higher than other coatings, due to its low porosity.

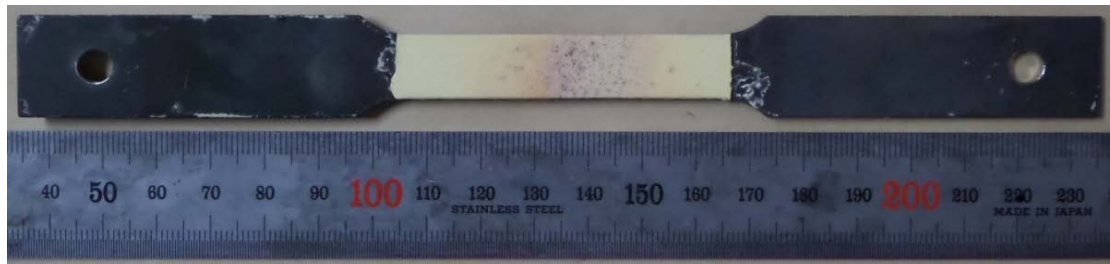
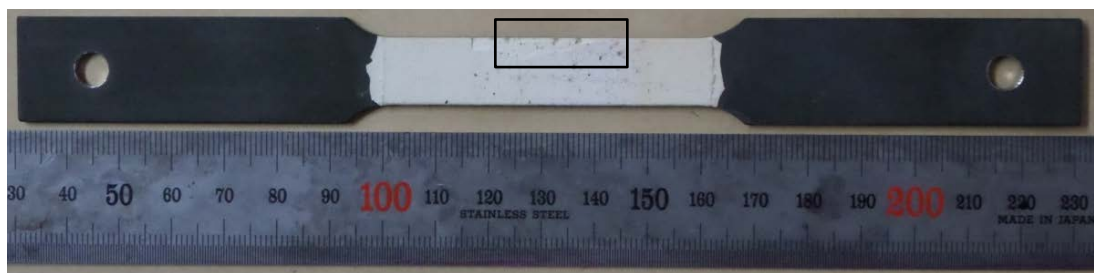
Fig. 4. Optical images of the TBC samples before and after the first set TGMF tests heated at 850 °C: (a) sample #2, as-sprayed SCL porous 8YSZ TBCs, (b) sample #2, SCL porous 8YSZ TBCs after 1200 TGMF cycles, (c) sample #3, as-sprayed DCL porous 8YSZ+ La₂Zr₂O₇, (d) sample 3, DCL porous 8YSZ+ La₂Zr₂O₇ after 220 TGMF cycles, (e) sample #4, as-sprayed DCL dense 8YSZ+ La₂Zr₂O₇, and (f) sample #4, DCL dense 8YSZ + La₂Zr₂O₇ after 50 TGMF cycles.

Blocks highlight the failure sites.

Fig. 4 shows the optical images of the samples before and after the TGMF tests heated at 850 °C. As shown in Fig. 4 (a) and (b), after 1200 cycles, there was no crack or spallation tendency in the single layered porous 8YSZ coatings. As shown in Fig. 4 (b) ~ (f), the double layered La₂Zr₂O₇ can't last many cycles. In Fig. 4 (c) and (d), the double layered porous 8YSZ and La₂Zr₂O₇ coatings (sample 3) delaminated on the edge after 220 cycles. In

Fig.4 (e) and (f), the double layered dense 8YSZ and $\text{La}_2\text{Zr}_2\text{O}_7$ coatings delaminated after 50 cycles.

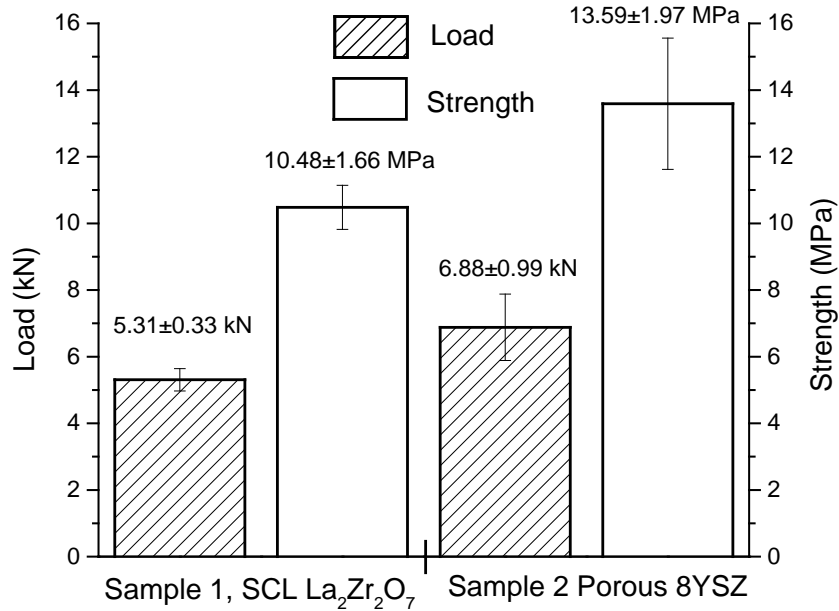
Fig. 6. Load and adhesive strength values for single layered coating samples.

As shown in Fig. 6, the tensile load and adhesive strength of 8YSZ samples were higher than those of $\text{La}_2\text{Zr}_2\text{O}_7$. The adhesive strength was calculated by dividing the tensile load with the cross section area of the tensile bar samples. The difference in the tensile load and adhesive strength is primarily caused by fracture toughness [22]. Previous studies have showed that $\text{La}_2\text{Zr}_2\text{O}_7$ standing coatings have a lower fracture toughness than that of 8YSZ coatings ($2.2\sim 3.3 \text{ MPa}\cdot\text{m}^{1/2}$ for 8YSZ, and $1.1 \text{ MPa}\cdot\text{m}^{1/2}$ for $\text{La}_2\text{Zr}_2\text{O}_7$), suggesting $\text{La}_2\text{Zr}_2\text{O}_7$ coatings are prone to fracture under tensile load [7, 21, 23]. Therefore, $\text{La}_2\text{Zr}_2\text{O}_7$ TBC samples are expected to have lower adhesive strength than that of 8YSZ.

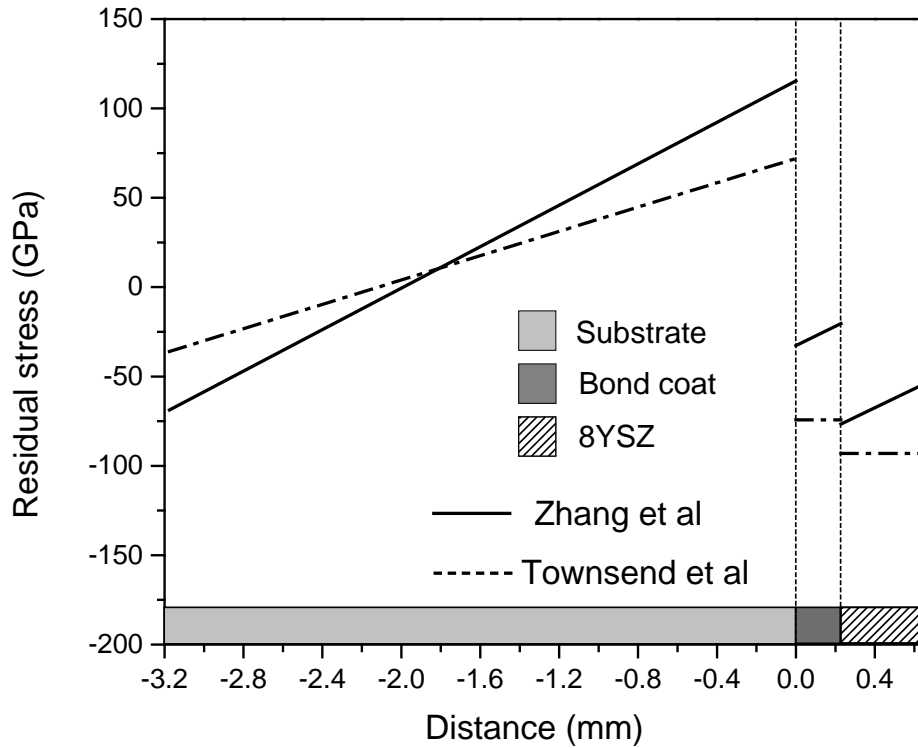
Fig. 8. Residual stress distributions as a function of coating thickness: (a) residual stress distribution in SCL $\text{La}_2\text{Zr}_2\text{O}_7$ sample and (b) residual stress distribution in SCL 8YSZ sample.

The calculated thermal residual stress from equations (1) ~ (6), along with Townsend's thermal stress model, is shown in Fig. 8 [26]. The compressive residual stress difference at the interface of SCL $\text{La}_2\text{Zr}_2\text{O}_7$ coating was about 3 GPa larger than that of SCL 8YSZ. Due to the residual stress discrepancy, there were more defects, such as grain boundaries and pores, near the interface area of SCL $\text{La}_2\text{Zr}_2\text{O}_7$ TBCs, which is consistent to the SEM images in Fig. 7 (b) and (d). Since there were more distributed grain boundaries in $\text{La}_2\text{Zr}_2\text{O}_7$ than 8YSZ, so the $\text{La}_2\text{Zr}_2\text{O}_7$ ceramic layers were easily to break. Besides, comparing to the interface, the $\text{La}_2\text{Zr}_2\text{O}_7$ layers were much weaker due to their lower fracture toughness and scattered boundaries[21], so the spallation occurred inside the $\text{La}_2\text{Zr}_2\text{O}_7$ coating layer instead of interface. Similarly, the adhesive strength in $\text{La}_2\text{Zr}_2\text{O}_7$ TBC samples was lower than that of 8YSZ, which showed that the spallation occurred much easier in the $\text{La}_2\text{Zr}_2\text{O}_7$ coating than 8YSZ.

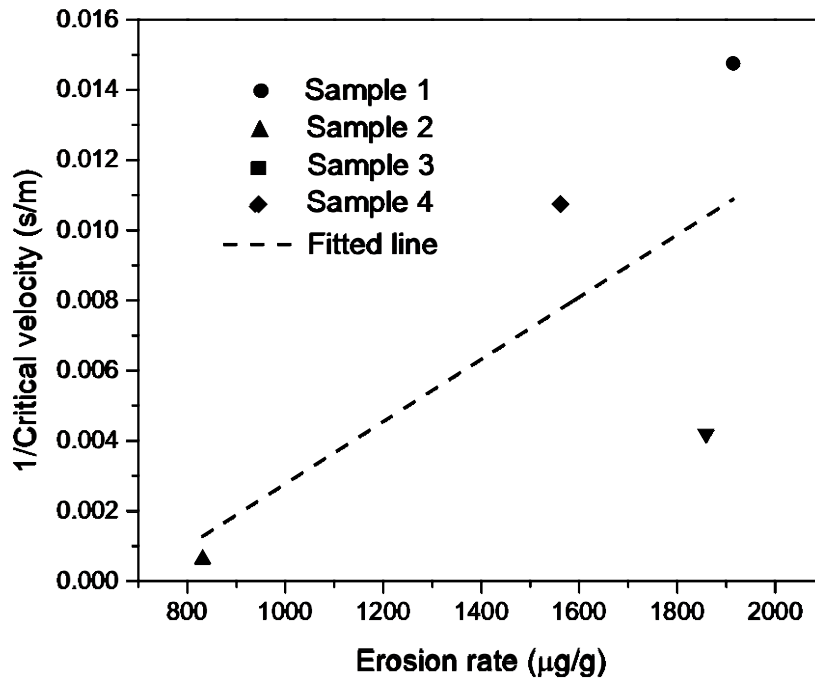
Fig. 14. Correlation between the inverse of the critical velocity and erosion rate.

Equation 7 provides a possibility of evaluating erosion resistance without conducting erosion experiment. As shown in Fig. 14, a linear fitting ($R^2=0.224$) between the inverse of critical erosion velocity and experimentally measured erosion rate, shows a general linear dependency, with the relationship $1/V_{crit} \text{ (s/m)} = 8.87 \times 10 \text{ (erosion rate, ug/g)} - 0.006$. Therefore, it becomes possible to predict erosion resistance using Equation 7 along with the physical properties, without doing the actual experiments.
